# “Beating” Effect Caused by Two Closely Spaced Mechanical Frequencies Observed on Two-Shaft, Gas Turbine Drive

# Two Shaft Gas Turbine Configuration

The subject gas turbine drive is a Solar Centaur 47 Gas Turbine located at a gas processing facility in South Texas.

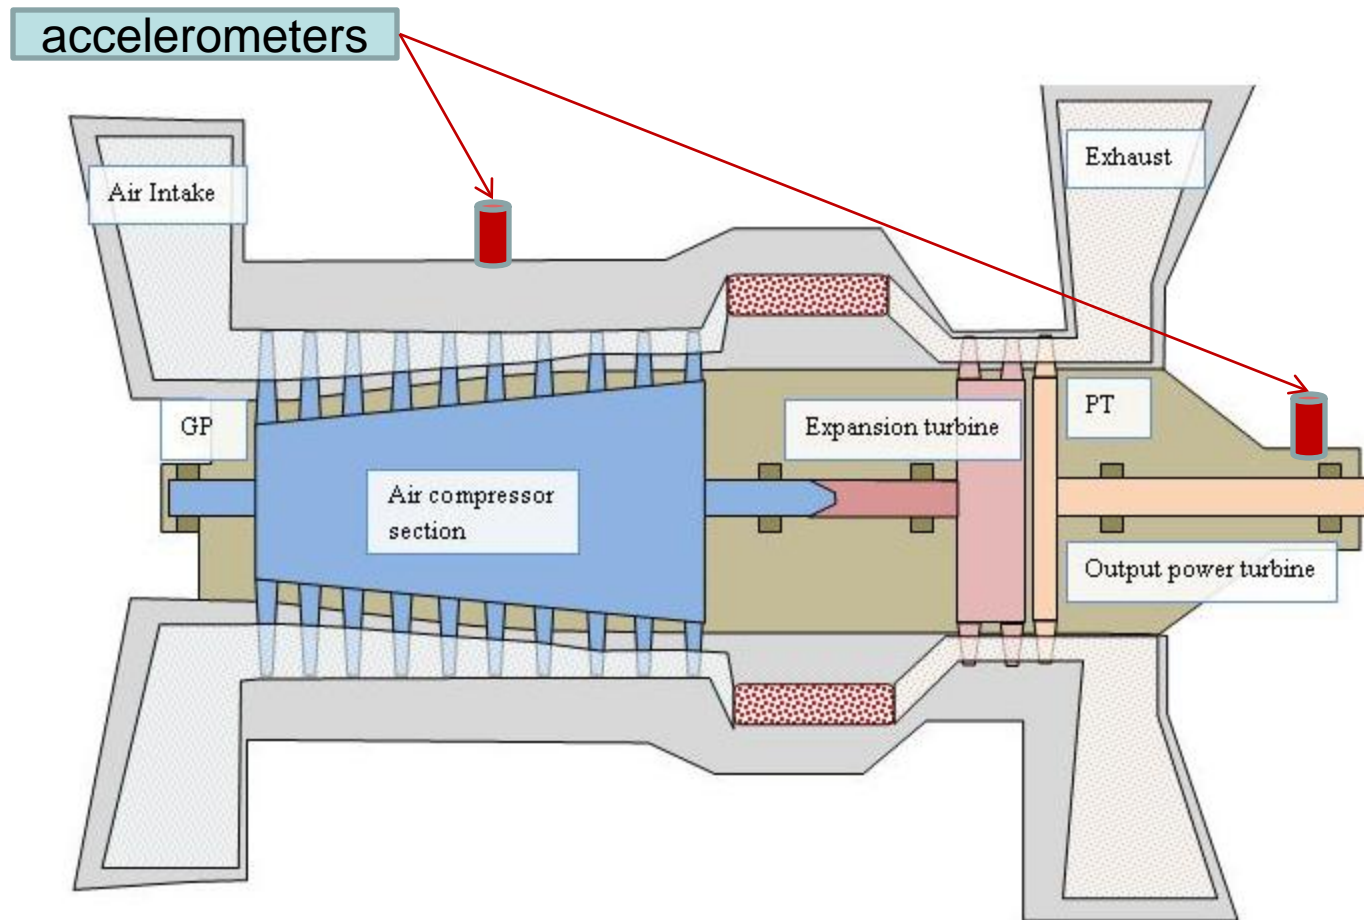
## Cross section of a similar two-shaft gas turbine

- Output power turbine (PT) and gas producer (GP) are on separate shafts.
- Share common housing.
- Only two accelerometers used for monitoring.

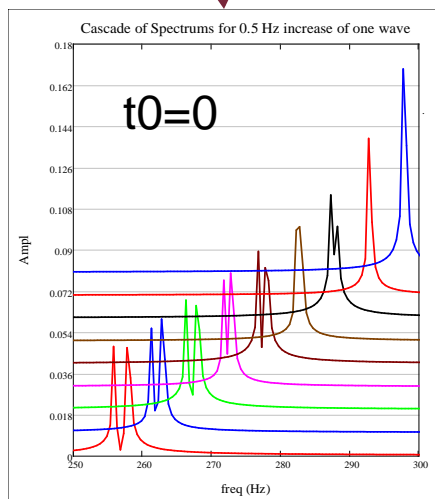
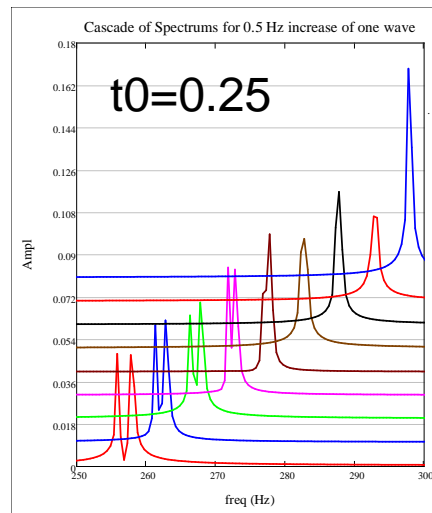
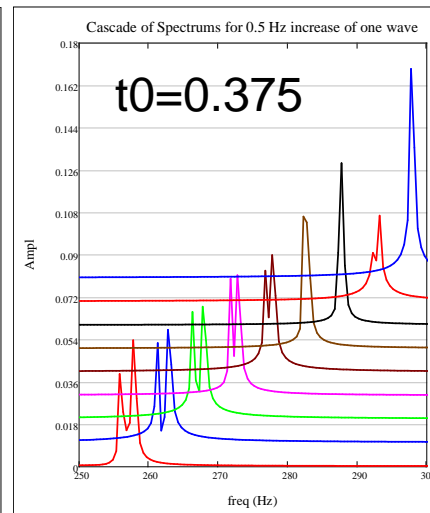
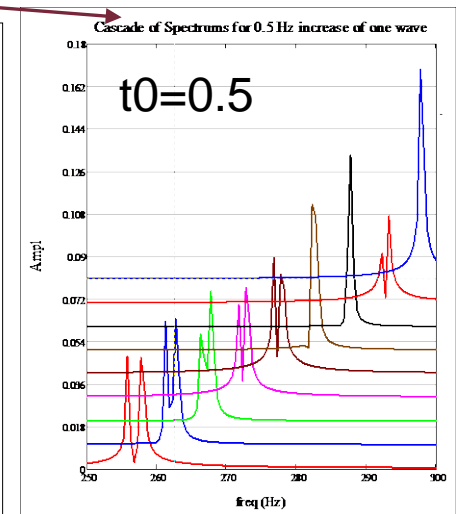
Fixed frequency  
 $f_2=258$  Hz

The four figures on the bottom are the spectrums if the start time of the 1 sec. sampling shifts to the right. This is essentially a phase change. No 1X pick up on PT-GP system.
